Archaeological Excavation
19th century lighthouse and gun mount
Headland, Hartlepool

Archaeological Excavation

19th century lighthouse and gun mount

Headland, Hartlepool

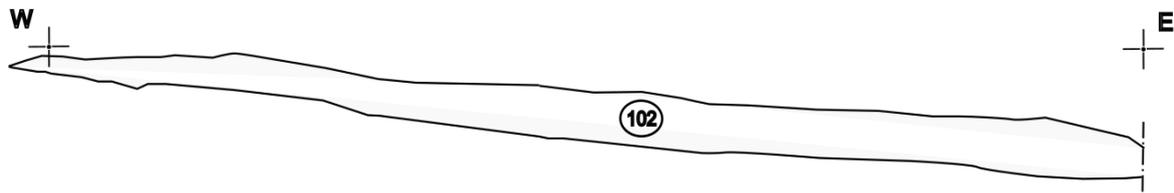
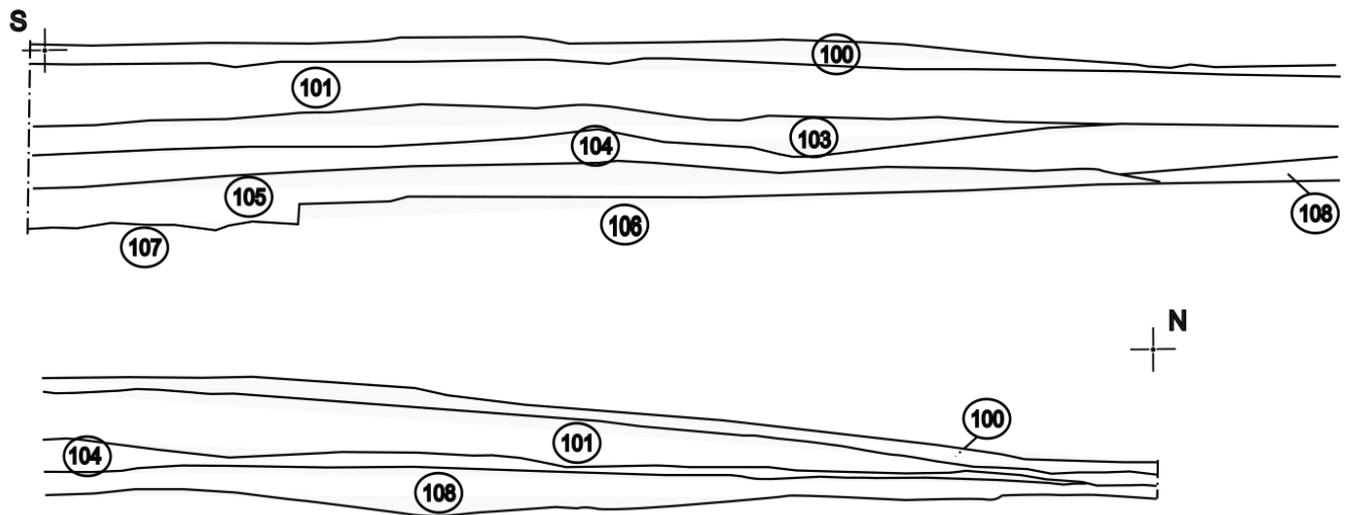
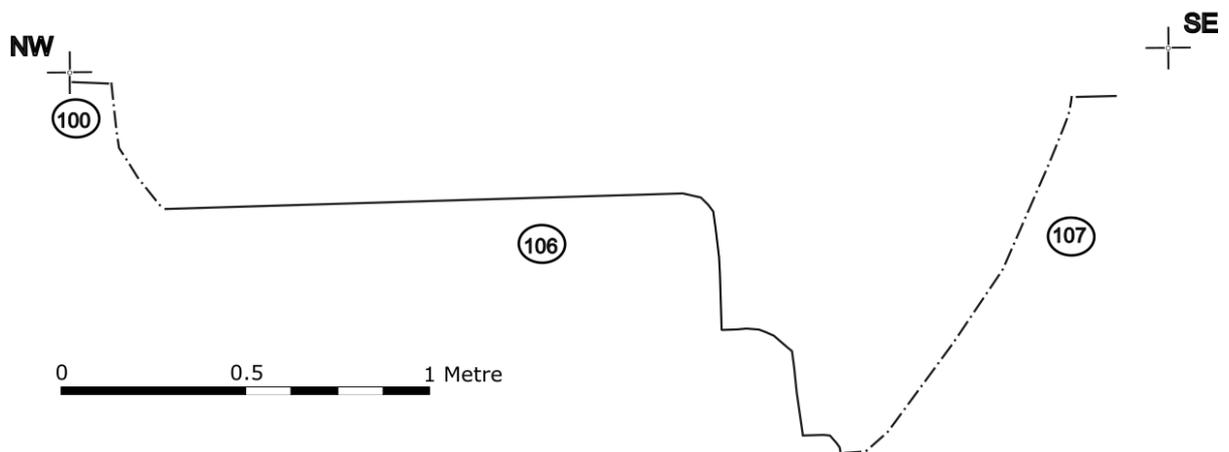
Figure 5: Trench 1 Sections

Section 1: Internal trench section

Section 2: Trench section

Section 3: Lighthouse base profile

The earliest deposit encountered was the stepped foundation of the former lighthouse base and the contemporary overlying circular white sandstone lighthouse base (106). The foundation continued below the excavation limit. Excavation timescales did not allow further investigation. No masonry marks were recorded on the slabs however there was evidence of chisel marks and precision cut rectangular lifting holes or Lewis holes. Lewis or Lewisson the name deriving from a lifting device that was often used when stones were of a particular shape and/or chains and slings could not be used to place them in position.

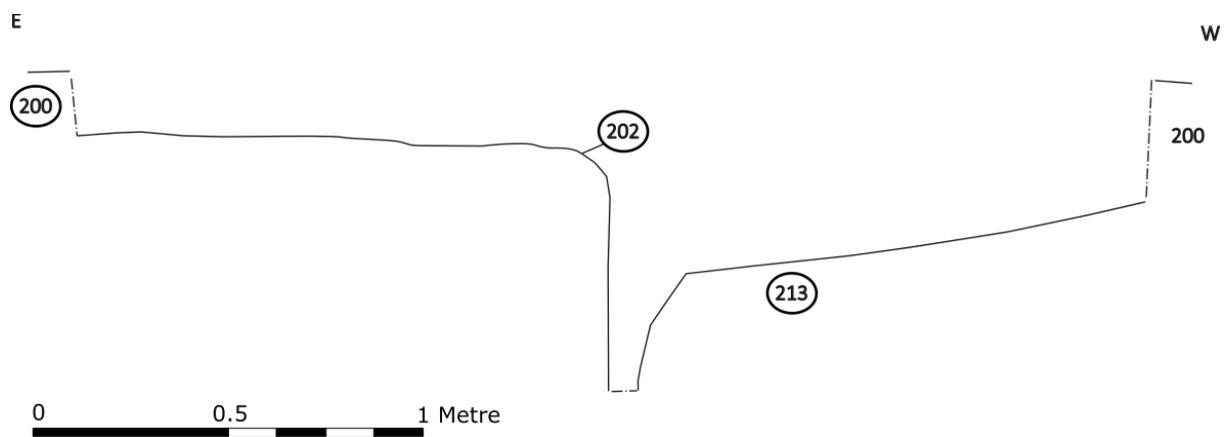
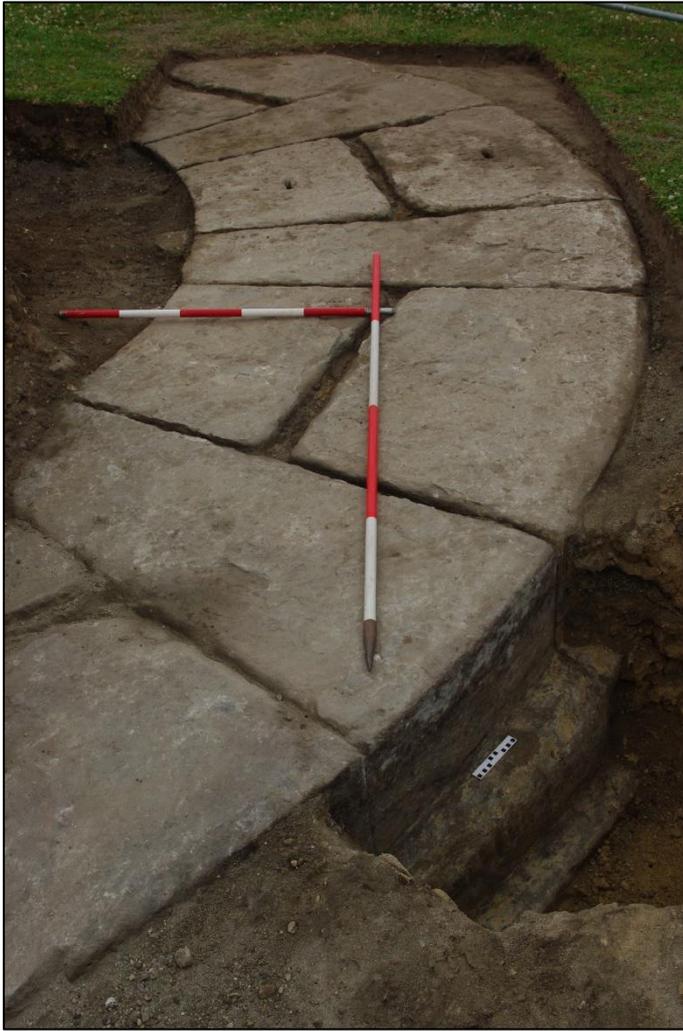
Figure 7: Trench 2 Sections

Section 1: South facing section along Trench 2

Section 2: Profile across trench showing angle of concrete apron/barbette

The earliest deposit was the concrete apron of the former lighthouse gun battery (202). This was exposed in the east and south part of the trench. The concrete apron would have served to protect the gun and deflect incoming fire. Concrete aprons were often circular, but some did only occupy the seaward side of the gun position. The gun would have been positioned in a pit or chamber to the rear of the apron, in this case to its north-east.

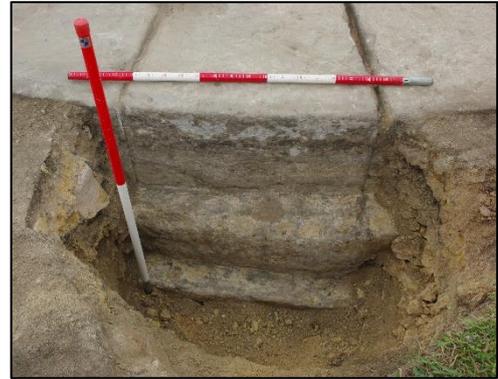
Figure 8: The white sandstone lighthouse base (106) and stepped foundation in Trench 1. Lewis holes are visible in the north part of the image, looking north

It was therefore a surprise and a delight to uncover the intact base of the lighthouse. At present, we know that the foundation consisted of at least three courses of white sandstone although complete excavation of the depth of the foundations could not be ascertained during this short dig. The material which had been used to infill the site after 1956 and before landscaping had strong connections with the inter-war/post WWII time period.

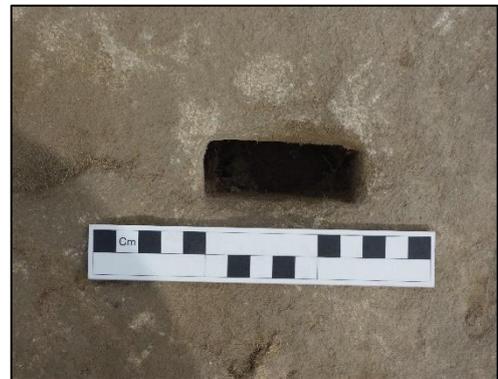
Figure 9: Detail of the stepped foundation

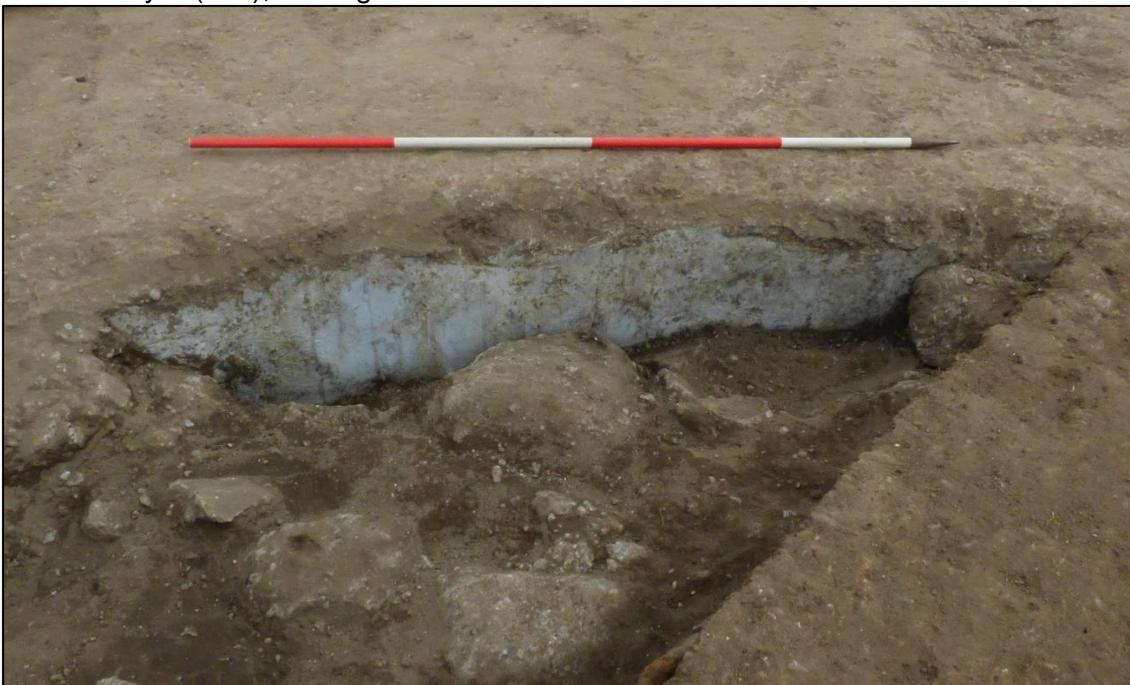
Figure 11: Trench 2 showing the concrete apron (202) and the concrete demolition rubble in layer (213), looking south

Above the concrete was the post-demolition backfill deposit (213) that contained a high quantity of large concrete pieces from 0.3m to 1.2m in size. Many of these were left in situ as they were too heavy to remove. A small sondage was excavated through this layer to expose part of the vertical face of the gun battery apron, but the bottom of this deposit was not reached. In the north part this deposit was below a layer of mottled orange and dark black-brown sand (212) 0.14m thick.

According to expert Joe Foster it appears, based on its size, shape and girth, that the excavated apron of the gun mount was the original 1860 concrete, constructed to house the Mark VI hydro-pneumatic gun. This barbette had been a good enough size for the replacement Mark VII gun in the 1890s and was then wide and strong enough for the Mark 24-gun emplacement and remained the same when the later high-angle gun replaced the Mark 24. This means that the narrow apron for the Mark VII gun, suggested by the available literature, was never introduced at the Lighthouse Battery, which retained its non-standard wider aproned emplacement. This also means that the new replacement in 1938 also used the original wider apron, rather than the suggested inner apron on pillars and enlarged pit with extended apron with lipped rim. Clearly, none of these alterations were made and the Headlanders at Hartlepool chose to beat to their own drum, rather than being dictated to from afar. From the excavation evidence uncovered, this gun mount is now unique in Britain as, so far from the available evidence, it appears to be the only surviving 1860-gun mount in Britain.

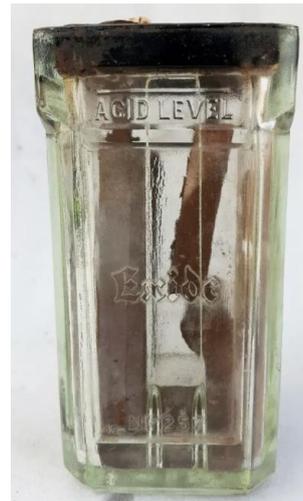
Figure 23: Lead Acid Battery fragments and image of complete battery - Trench 1

Several scraps of lead were recovered. In addition, a piece of lead coated copper cable was found and parts of a Lead Acid Battery (see Figure 23).

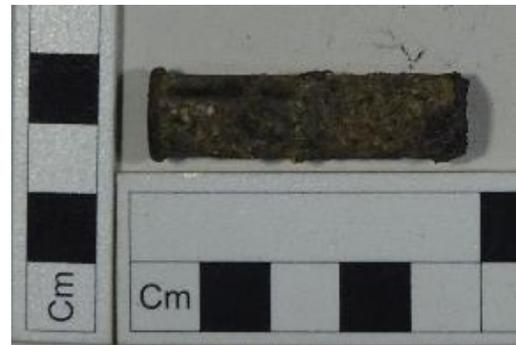
Figure 25: .303 rifle cartridge Trench 1

A few scraps of copper alloy were found and in addition a .303 rifle cartridge case missing its primer (see Figure 25). An early 20th century pressed uniform button, and two King George V pennies were also found.

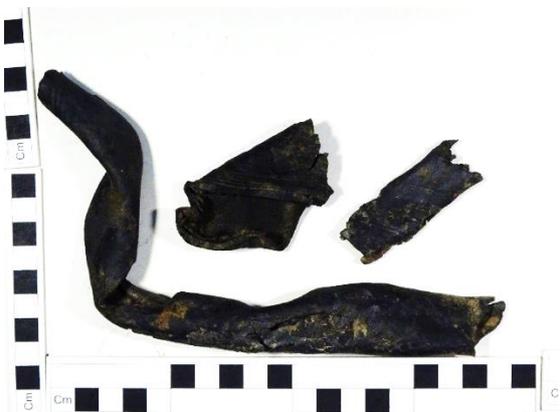
Figure 26: Bicycle tyre and inner tube – Trench 2

Rubber: Two pieces of inner tube and one of tyre of bicycle were found in Trench 2 (see Figure 26).
